CORROSION-RELATED EQUIPMENT FAILURES IN NIGERIA OIL/GAS INDUSTRY: A CASE STUDY

Atanmo, P. N. and Nwankwo, E. I.

Department of Mechanical Engineering, Chukwuemeka Odumegwu Ojukwu University, P.M.B. 02 Uli. Anambra State. Nigeria.

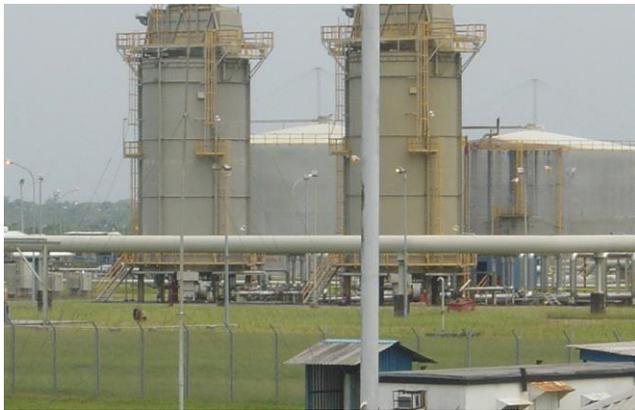
Fig. 1: Corroded Re-heater column walls

Figure 1 shows re-heater columns and settling tanks (background) for crude oil storage in Isiope facility, southern Niger-Delta. The walls of the re-heater columns and settling tanks show severe and prominent corrosion attacks. These are clear indications of environment effects. The internals of the vessels were not examined because as at time of inspections, they were in active service. Cycles of rains, sunshine and humidity have combined to produce the corrosion. Condensation initially weakens the protective coating. The coating progressively gives way to fresh metal surface; localized material surface depletion commences and progresses on the bare metal surface. The valves experienced extensive pitting and perforations to about 16 % metal loss.

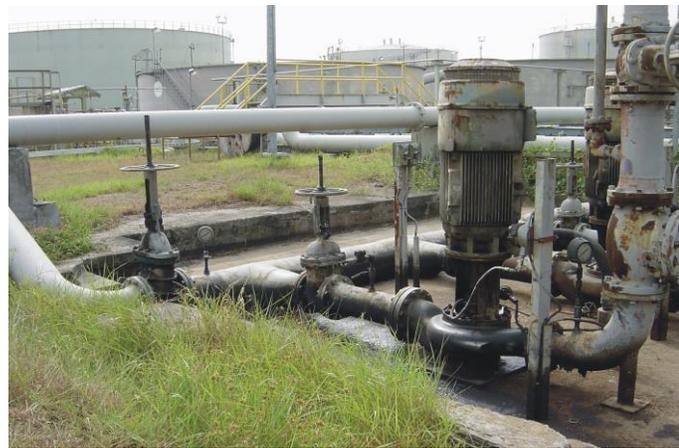
Fig. 2: Corroded valves, electric motor, pump and elbow

Figure 2 shows an integral of vertically-mounted electric motor with a submersible pump. There are also pipeworks and valves. Generally, the equipment were protected by paint coatings. There was not any form of sacrificial corrosion (cathodic protection) material in the “circuit.” Thus the electric motor, surface exposed part of the pump together with the pipes and valves freely corroded on environmentally-induced paint coating removal. Crevice-type of corrosion was very severe and prominent.
